Client: Permakai
Location: 81B Morley Road, Waiuku
Date: May 2, 2022
Time: 11:30 am
Conditions: sunny

Model: VARI showing plant health
Min: -0.299
Max: 0.346

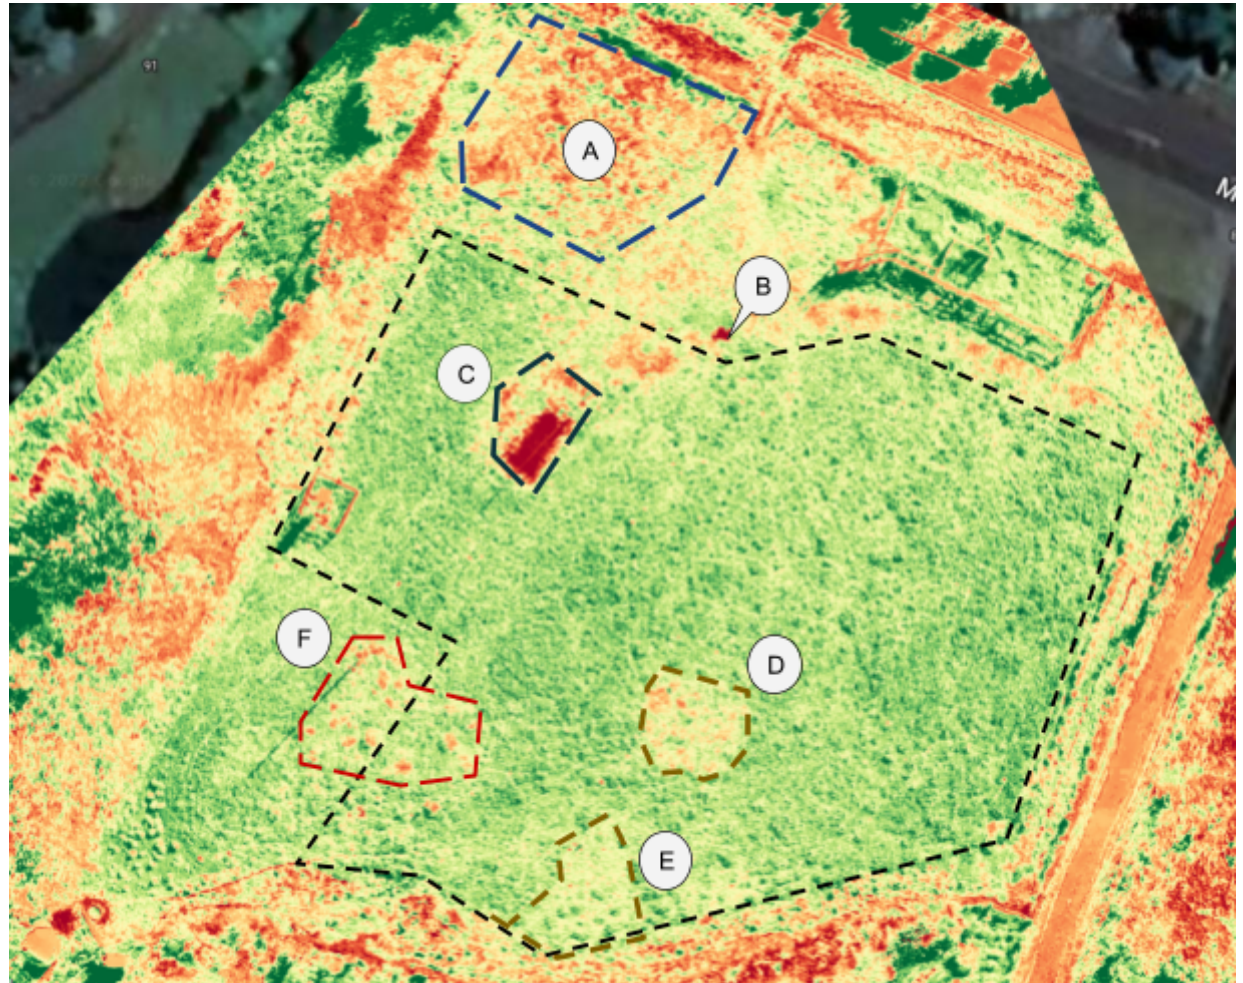
Areas of possible concern identified with explanation provided by owner

- A - area flooded by stream
- B - bare soil where carcass buried
- C - disturbed area around site of removed container
- D - degraded soil from previous burn pile
- E - subject to flooding from stream
- F - needs visual investigation

Dashed area has been recently sown with fresh pasture mix

Area outside of the dashed area is old pasture.

Note: VARI provides good indicative results. It displays the vegetation density and shows where crops are less dense than others. The red markers indicate crop stress points.
